DEPARTMENT OF TRANSPORTATION

Contract #: 04-0120F4Cty: SF/ALA Rte: 80 PM: 13.2/13.9File #: 69.28**WELDING INSPECTION REPORT****Resident Engineer:**Pursell, Gary**Address:** 333 Burma Road**City:** Oakland, CA 94607**Report No:** WIR-000666**Date Inspected:** 19-Oct-2007**Project Name:** SAS Superstructure**OSM Arrival Time:** 1430**Prime Contractor:** American Bridge/Fluor Enterprises, a JV**OSM Departure Time:** 2300**Contractor:** Zhenhua Port Machinery Company, Ltd (ZPMC), Changxing Island **Location:** Shanghai, China

OBG-CLOSED RIB TRIALS

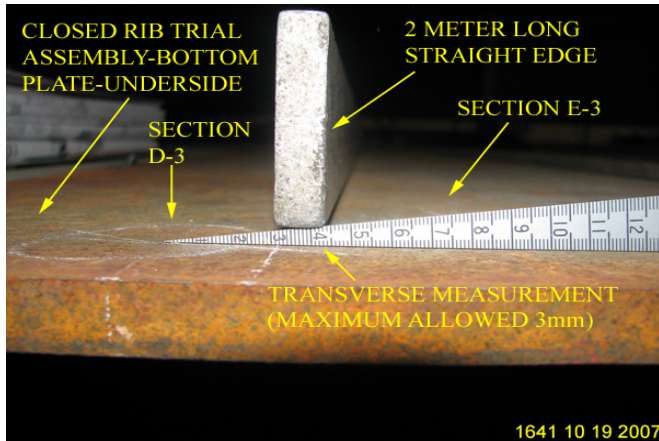
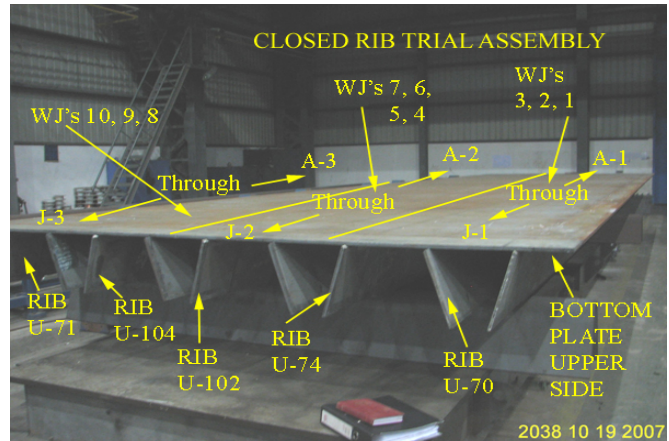
The Caltrans Quality Assurance (QA) Inspector Charlie Franco was present at the time requested by ZPMC QA Representative Eric Hu, to randomly verify transverse and longitudinal flatness of the Closed Rib Trial Assembly after the welding of the closed ribs onto the bottom plate of the Closed Rib Trial Assembly. The QA Inspector was assisted by QA Inspector Roscoe Dixon. The QA Inspector was informed by ZPMC QA Representative Fu Yuhong, that ZPMC had previously performed their verification of the transverse and longitudinal measurements. The QA Inspector utilized a 1 meter and a 2 meter straight edge to perform the flatness verification. The QA Inspector randomly observed that the underside of the bottom plate of the Closed Rib Trial Assembly, had been divided into sections A through J longitudinally and sections 1, 2 and 3 transversely. The QA Inspector randomly verified 30 readings in the transverse direction and 30 readings in the longitudinal direction. The readings were recorded and forwarded to the Lead QA Inspector. The QA Inspector randomly observed that there were 2 transverse readings and 2 longitudinal readings that were in excess of the maximum allowed per the contract requirements. These readings were highlighted on the verification sheet which was forwarded to the Lead QA Inspector. The attached photographs provide additional detail.

ZPMC QC Representative Eric Hu informed the QA Inspector that the transverse and longitudinal verification measurements taken and recorded by ZPMC QC personnel, were performed with a level line on 50 millimeter blocks. Mr. Hu informed the QA Inspector that ZPMC had taken 15 longitudinal flatness verification measurements and 12 transverse flatness verification measurements.
